Ayia Marina Dam

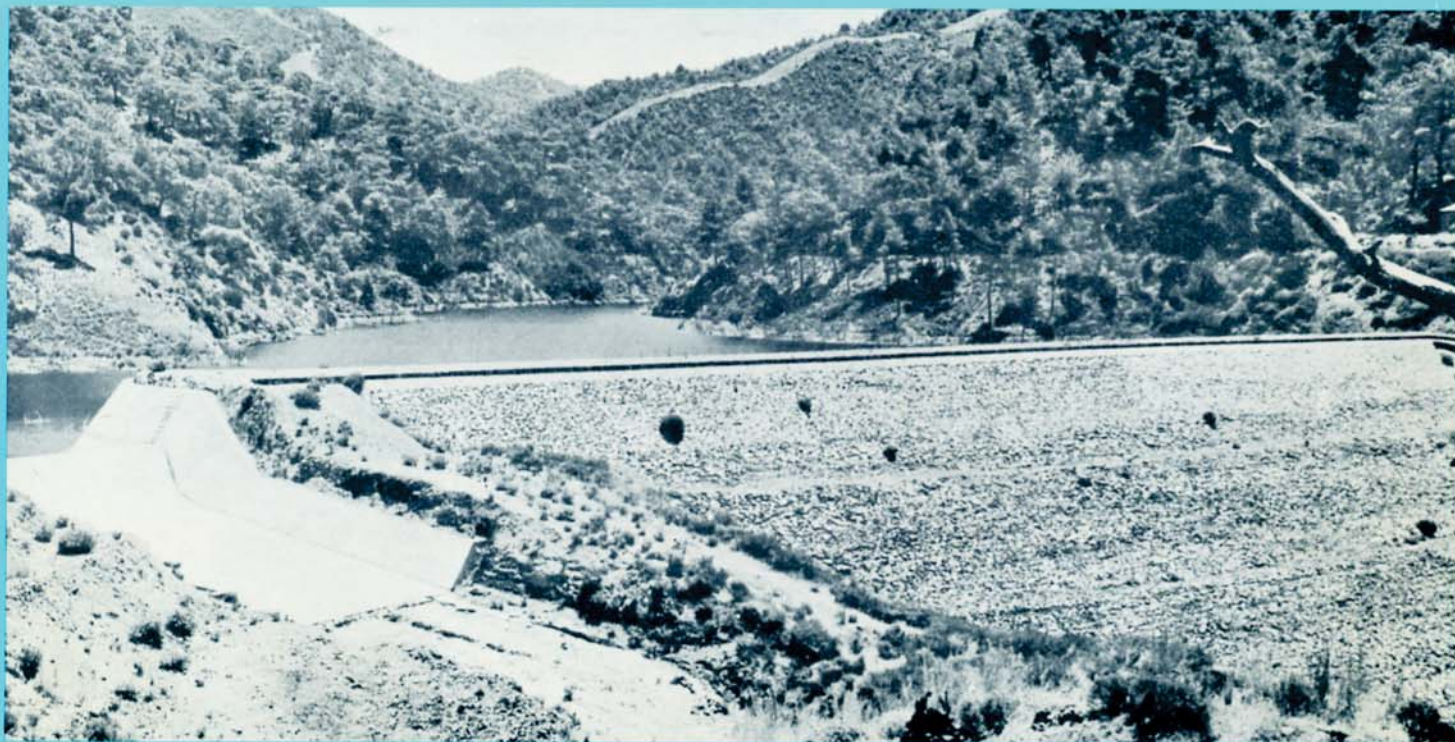
The Ayia Marina Dam is constructed on the Xeros River in the northern part of the Cyprus. The water impounded in the storage reservoir of 0.35×10^6 cu.m capacity is used for the irrigation of cultivated land located downstream from the dam site.

The dam site area is made up of diabase rocks (left abutment) and marl (right abutment). The water permeability tests performed provided satisfactory results so no grouting works have been carried out.

The spillway is located at the left abutment while the intake structure is located at the right one.
